Holybrook Dropped Kerb Survey -

2023

For review of Community & Environment Committee

Completed following resident feedback and in conjunction with Michelle Brown, Project Engineer, Environment Department, West Berkshire Council.

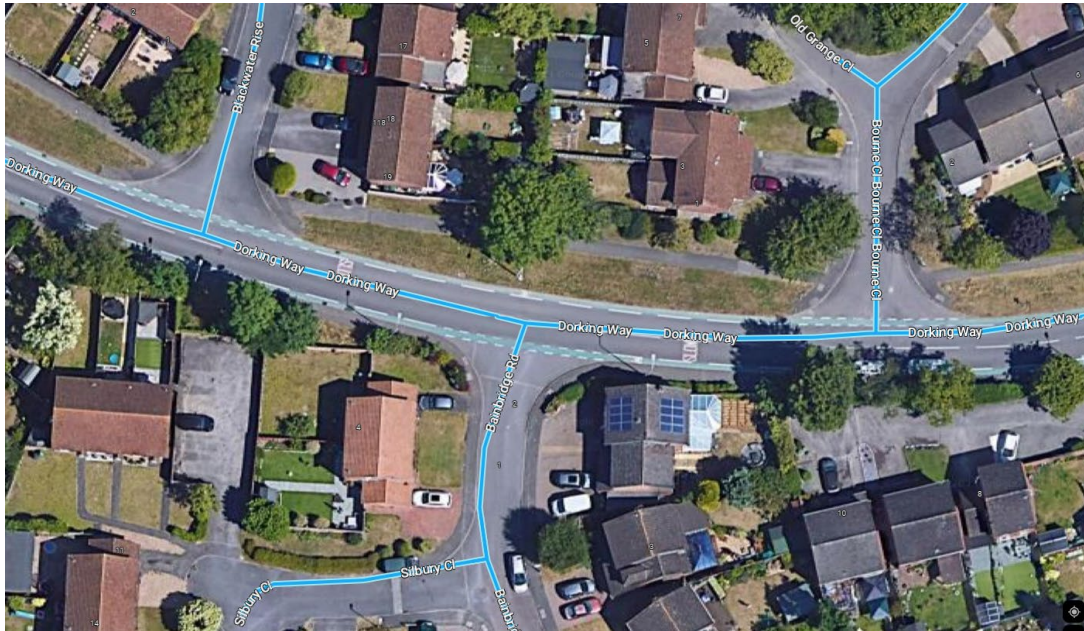
Dorking Way (Bainbridge Road)

There are already two dropped kerbs for driveway access (yellow highlight) but they do not align. Could the existing dropped driveway kerb be extended (blue circle) to allow for pedestrian crossing or would this be a conflict of highway access? If it is a conflict, would the rounded kerb edges be suitable?

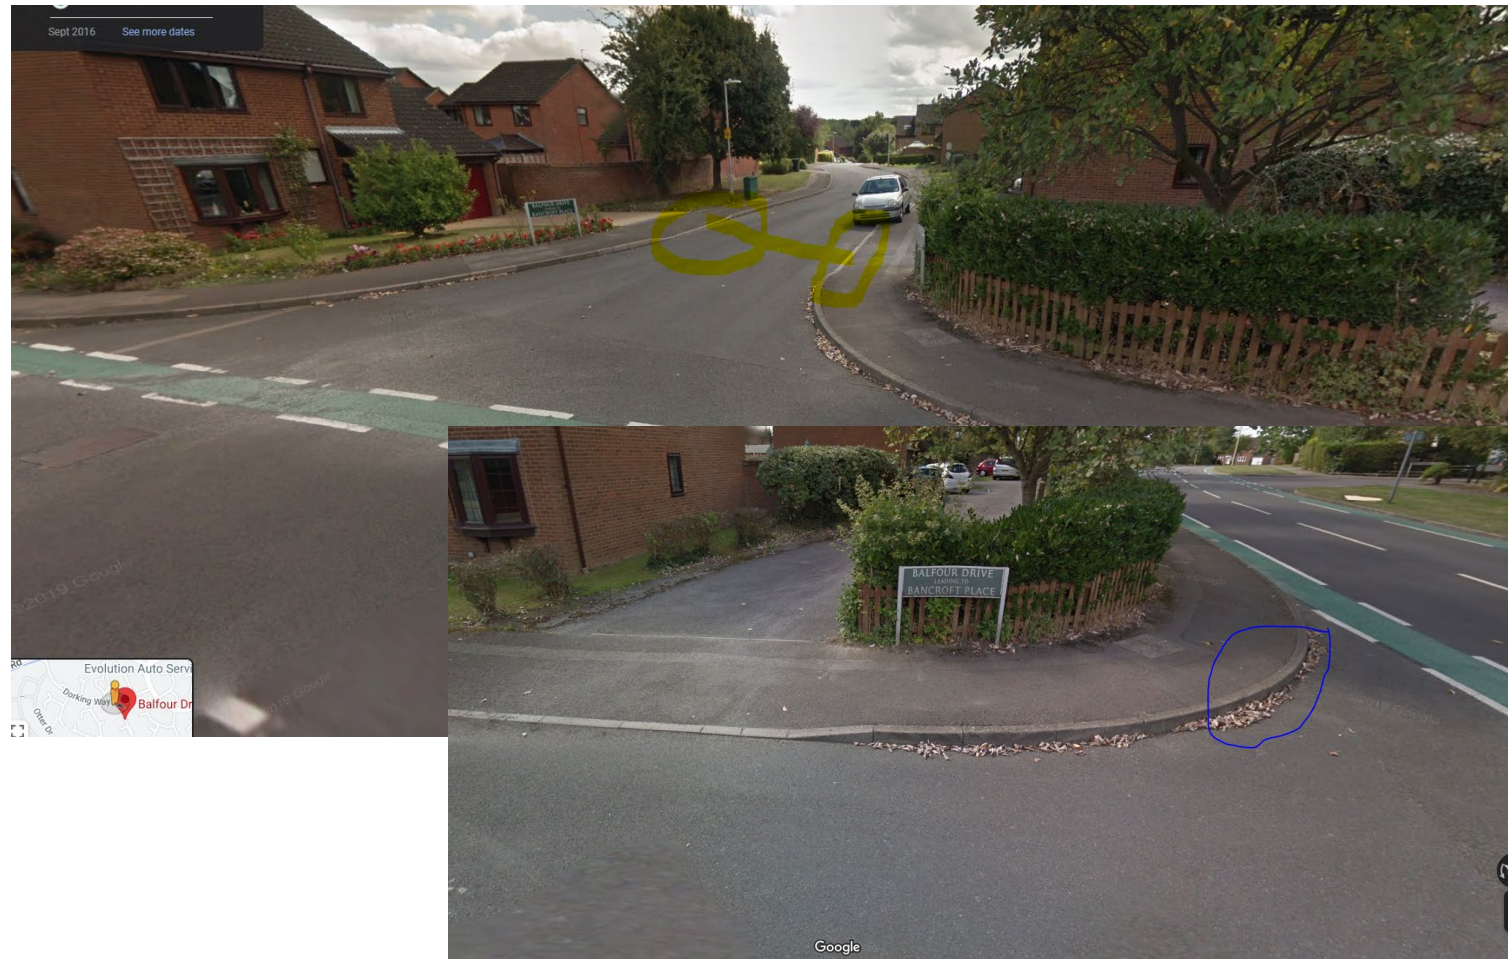
Access has been created for driveways, rather than pedestrians, but, in this case, the driveway accesses align. Because of the proximity of the right hand dropped kerb (as you face the road) to the street corner, I guess that a pedestrian dropped kerb here would not be possible unless you go from the rounded edges (note there are crossings on the rounded edges on the other side of the road at Camden Place for example?)

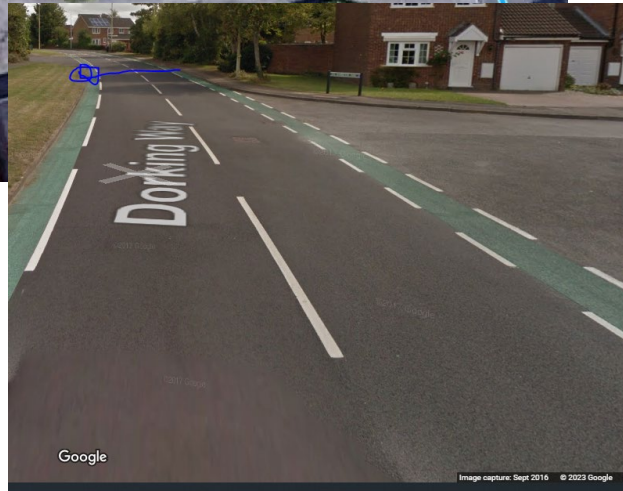
Dorking Way (nr Bourne Close)

Could we extend this footpath slightly to give access to the other side of the road:

Sight lines on Dorking Way would need to be checked as close to Bourne Close Road.

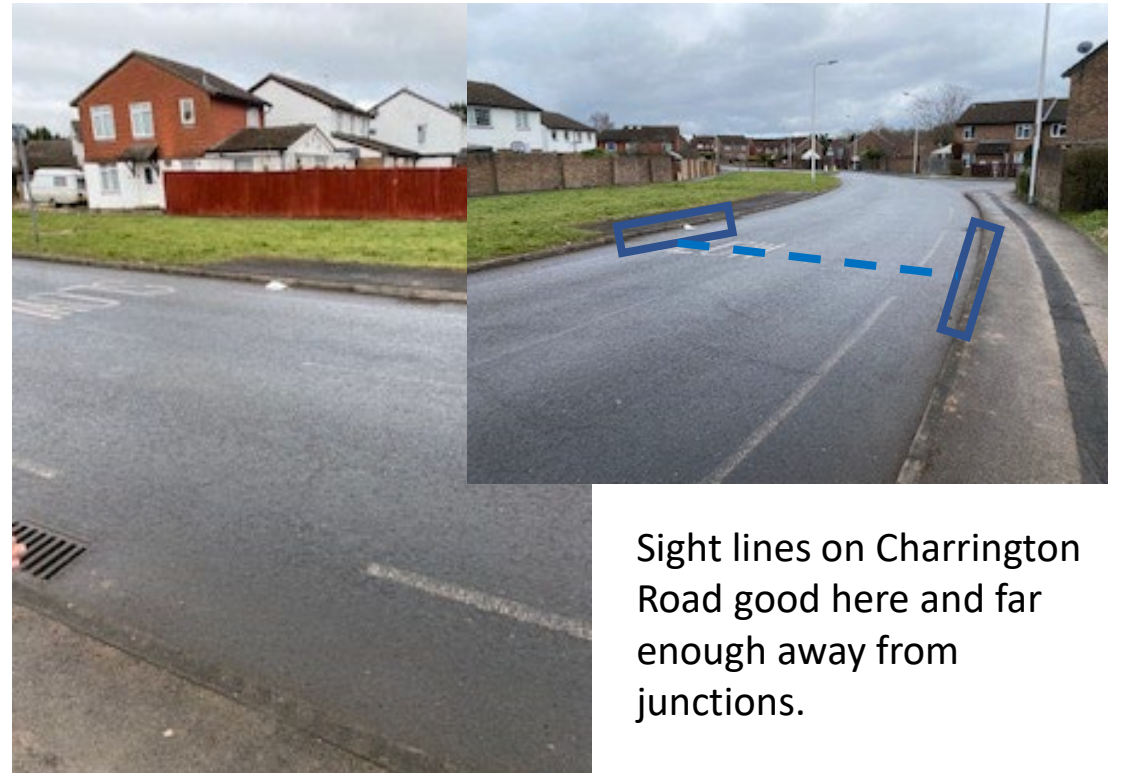
Suggest dropped kerb either side of Charrington Road to link footpaths (path on north side of the road ends abruptly with no crossing points).

Sight lines on Charrington Road good here and far enough away from junctions.

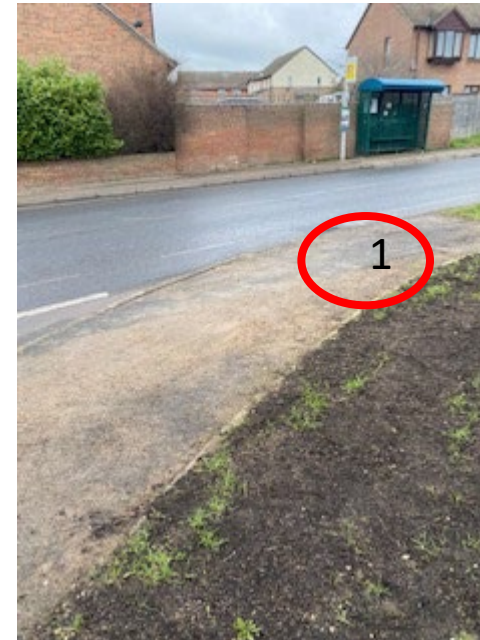
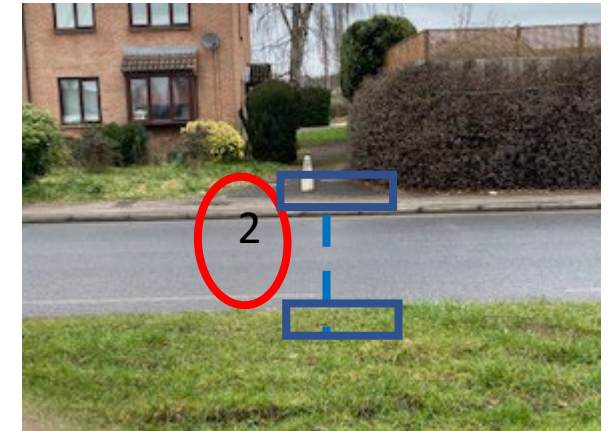
It is not safe to put a dropped kerb adjacent to Torcross (1) to enable access to the bus stop but dropped kerbs at the footpath of Porlock Place (2) is sensible.

Engineering works will be required through the grass verge. Slight embankment to kerb but do not think this will be an issue.

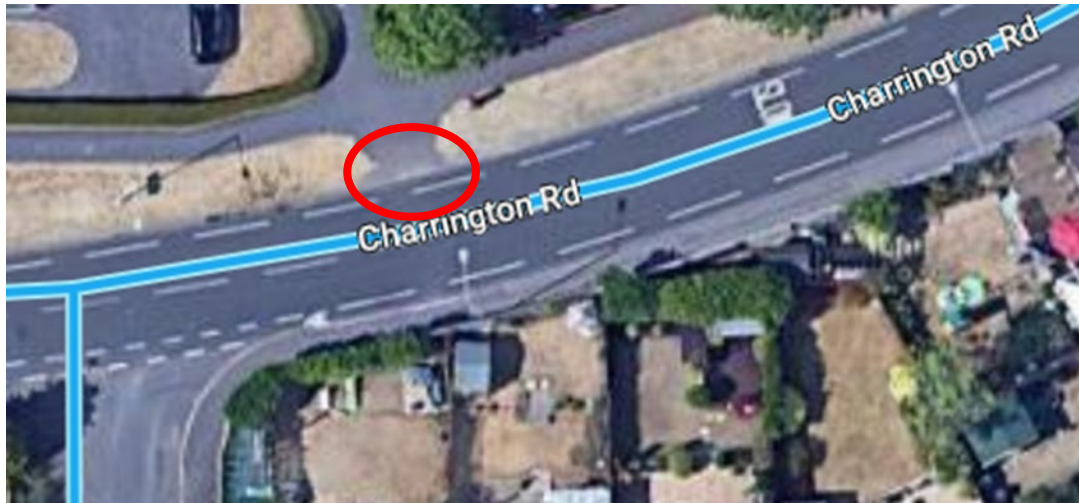
Charrington Road (Beansheaf Centre access)

Existing dropped kerb on the north side of Charrington Road is too narrow for disabled access. Consider widening to match south side.

The footpath access to this kerb is quite steep and would be difficult to navigate with either a pushchair or wheelchair.

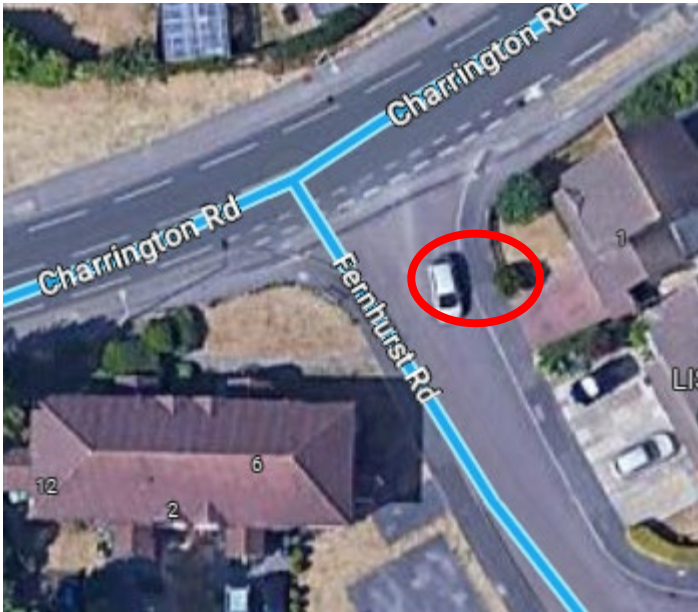
Fernhurst Road (Charrington Road)

Existing dropped kerbs are too narrow for disabled access.
Consider widening on both sides.

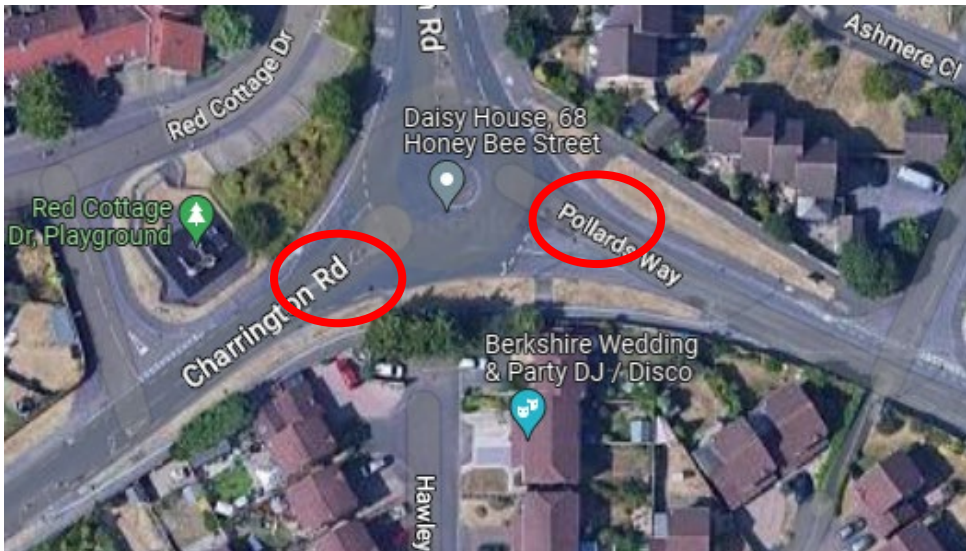
Charrington Road (roundabout)

Dropped kerb believed to be purposefully narrow for cyclists rather than pedestrians. Would ideally widen to enable better pedestrian crossing but not possible in the centre section because of the bollards. Recommend to leave both roundabout crossings as they are currently.

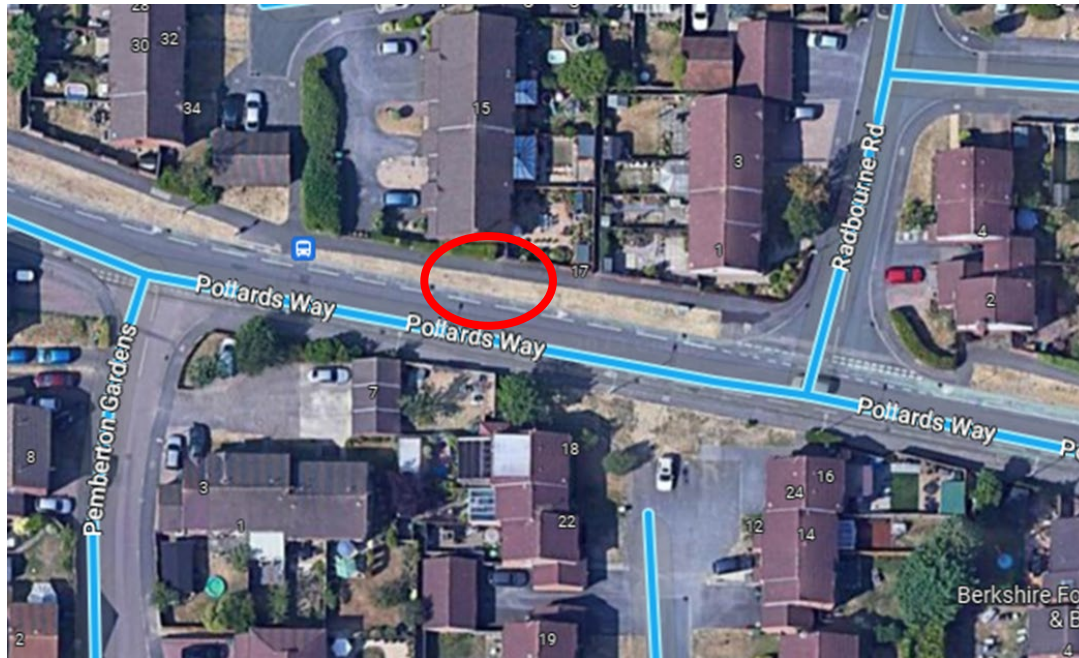
Pollards Way (Pemberton Gardens)

Dropped kerbs too narrow and too close to bus stop. Not very safe (assume intended for cyclists rather than pedestrians).

Suggest new dropped kerbs inserted a bit further towards Radbourne Road to provide a safe pedestrian crossing area from south to north of Pollards Way.

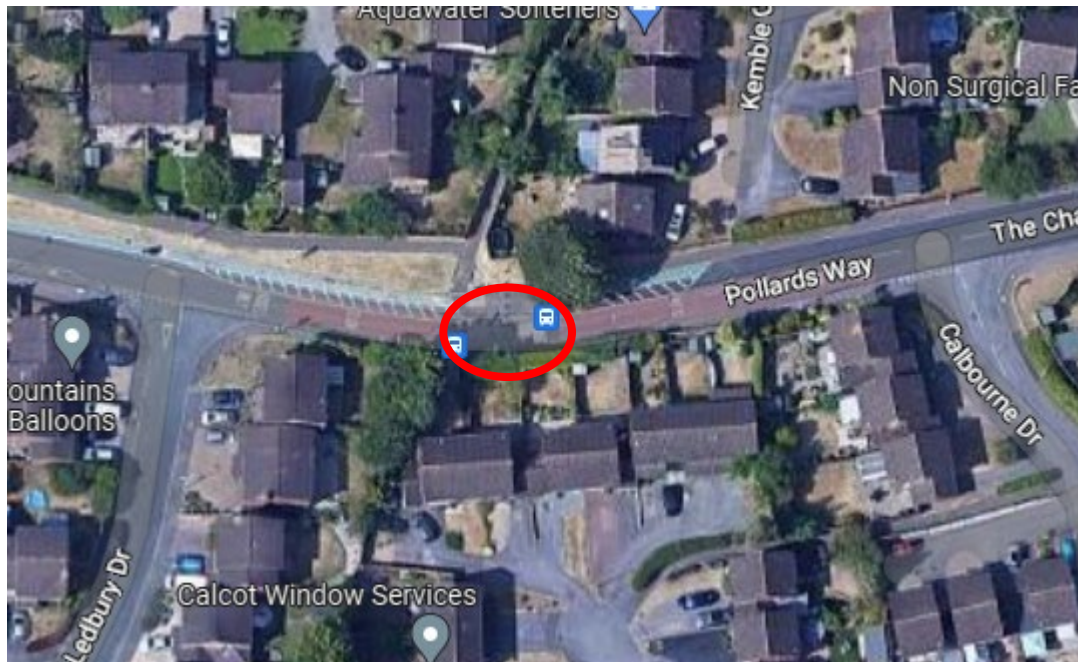
Bus sump (Pollards Way)

The bus sump is at its maximum permissible height. There are no other possible engineering works that can be done to stop other vehicles using the sump. Non-permitted vehicles use the sump at significant risk to their cars. Warning signage is good.

Condition of the actual sump is poor. Michelle agreed to ask her engineers to improve the surfacing.

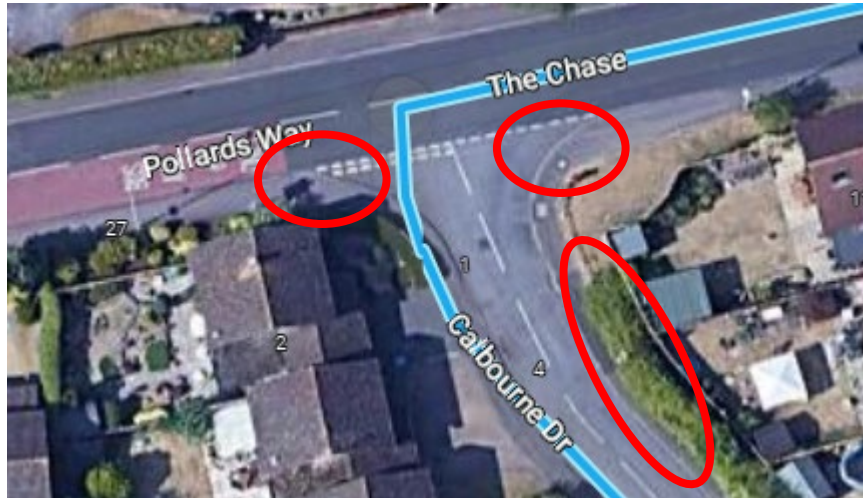
Calbourne Drive (The Chase)

NOTE: Witnessed lady with pushchair come off the pavement (post box side), walk along the (Pollards Way/The Chase) road and use the cyclist drop kerb, further down Pollards Way, rather than bump back up the kerb.

This crossing is not good. Dropped kerb required on road mouth on both sides. Visibility poor due to overgrown hedge.

Constraints:
utility covers,
particularly
near post box

The Clerk will ask the Parish Wardens to cut this hedge back by at least 1m to improve visibility around the curve in the road.

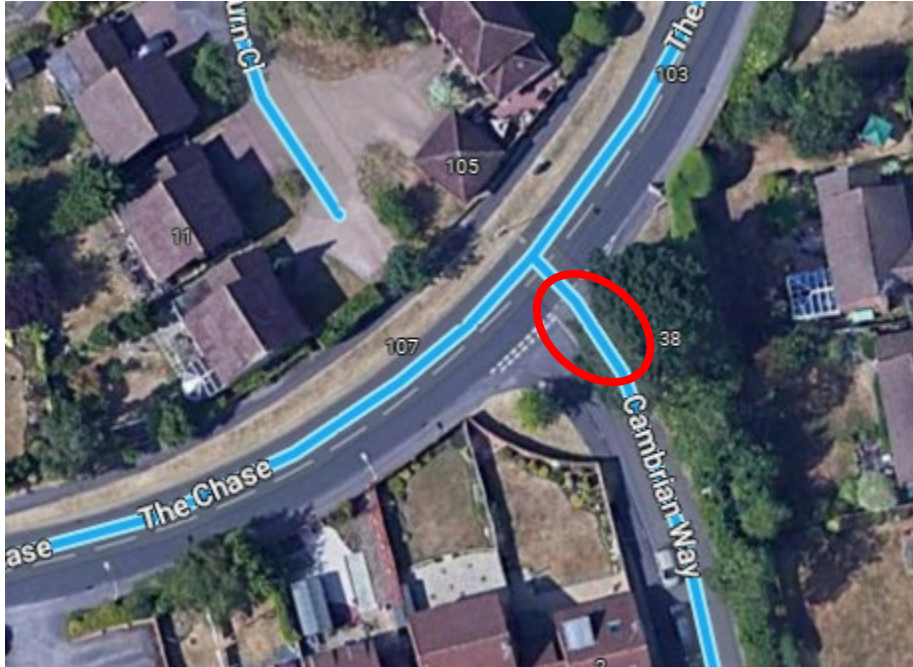
Cambrian Way (The Chase) and Grangely Close (The Chase)

Cambrian Way: Ensure dropped kerbs on both sides of the road making pedestrian connections.

Grangely Close: Although there are no pedestrian dropped kerbs on Grangely, the sightlines are poor and it would not be safe to install on this road.

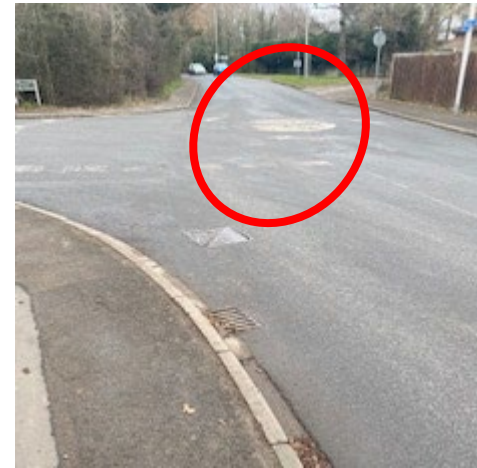
In the short space of time we were on this road we saw many vehicles ignoring the roundabout stop markings and continuing without looking (particularly from Carters Rise to Mill Lane) and we saw a vehicle cross the roundabout, from Mill Lane to the Chase on the righthand side of the roundabout.

Sightlines are poor but site constrained by private ownership.

Michelle confirmed that having the white lines re-painted will help encourage people stop at the junction.

- This roundabout and the one at the top of Calcot Place Drive to be re-painted in the new financial year.
- Old bus stop and hedge covering roundabout sign (Deerhurst) to be removed – Michelle.

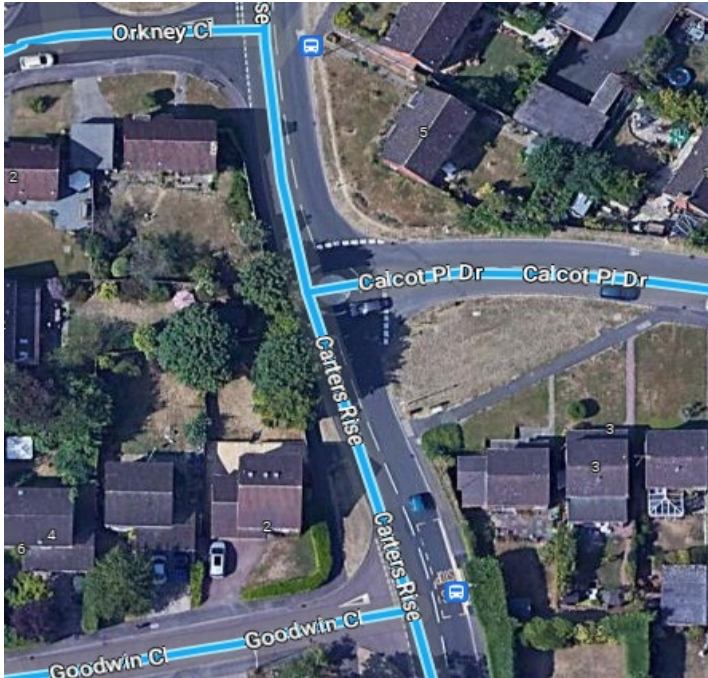
Carters Rise/Calcot Place Drive

Dropped kerb one side but not the other. Good location for a crossing but complex engineering on CPD side due to several man-hole covers. Requires further investigation with utilities.

Michelle confirmed that having the white lines re-painted will help people stop at the junction.

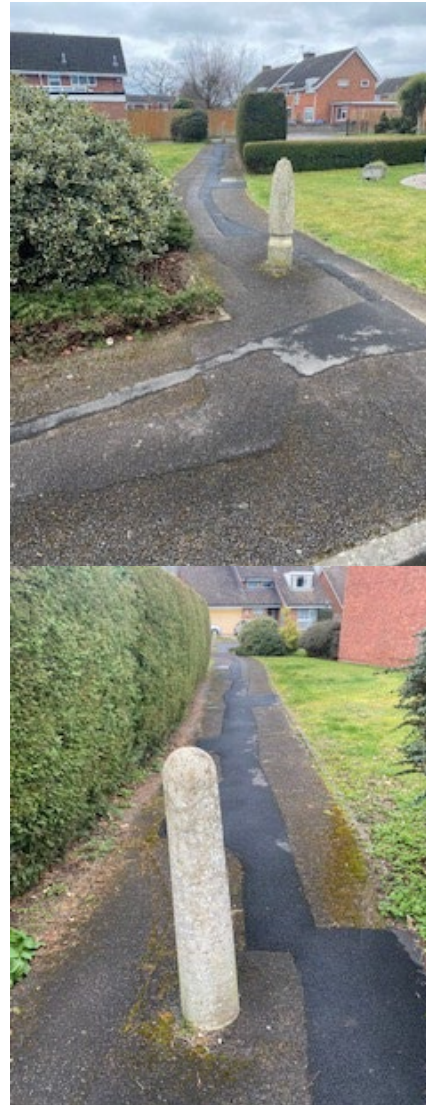
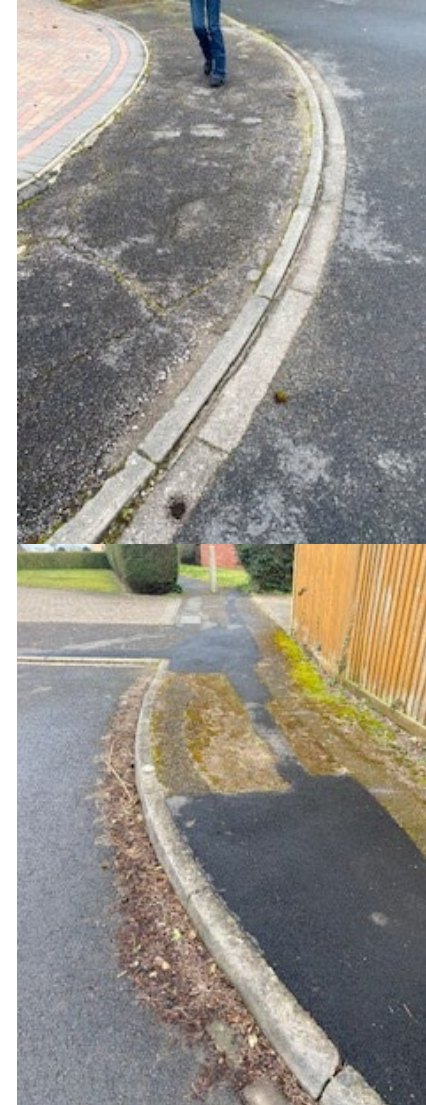
Footpath requires patchwork repair.

neighbouring hedge to be cut back (by resident).

Michelle to investigate purpose of and possible replacement of concrete bollards (poorly lit walk way).

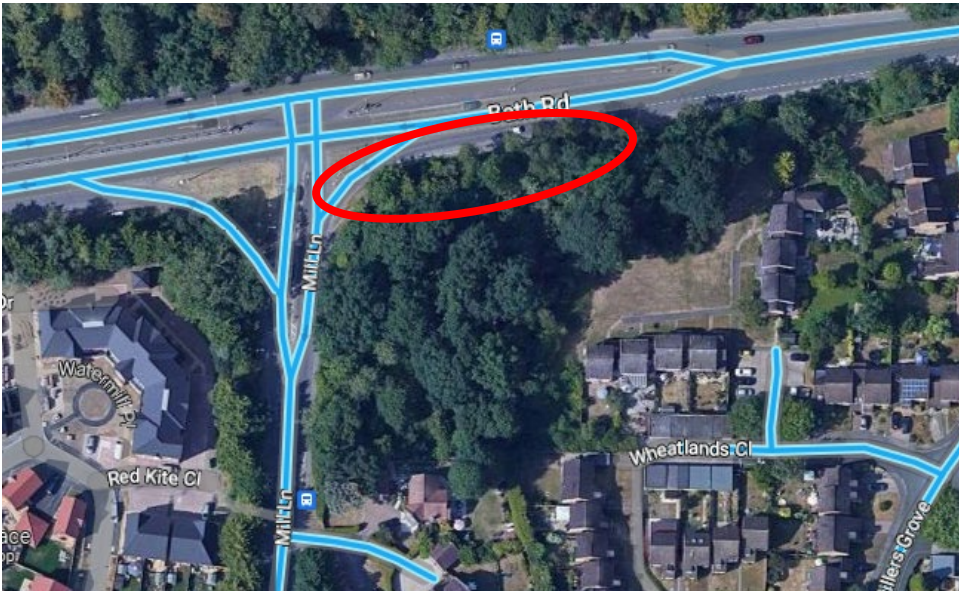
A4 Bath Road (facing Mill Lane)

Foliage overgrown and visibility reduced. [Michelle to contact Highways Team to cut foliage back to furthest possible point.](#)

Also, SUD (culvert) blocked and heavy with debris (drain full). [Michelle to arrange clearance.](#)

Discussed footpath options but land just behind foliage privately owned plus draining ditch and culvert. There are no other options other than cutting foliage back.

The corner (turning from A4 into Mill Lane) although not in perfect condition does not yet meet the requirement for repair.

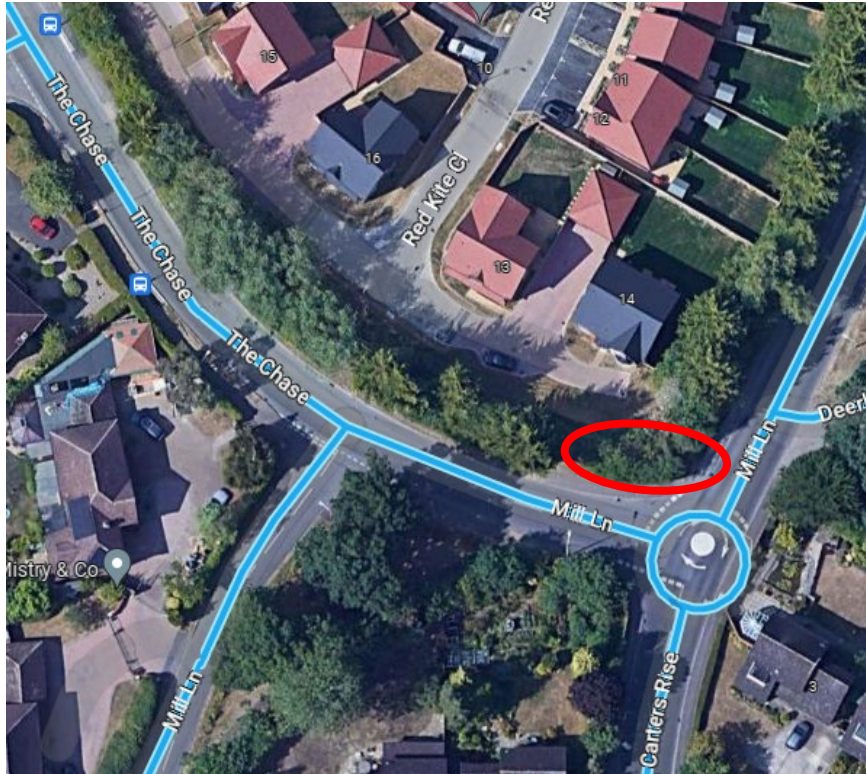
The Chase (crossing from Red Kite Close Side)

Foliage overgrown and visibility for pedestrian crossing severely reduced.
Michelle to contact Highways Maintenance Team to cut foliage back to furthest possible point – cut out first layer.

There are no safer places on this road to provide pedestrian crossings at the present time. This should be readdressed if any plans are approved for the old Heart FM site. The road is too narrow for a mid-way crossing point.

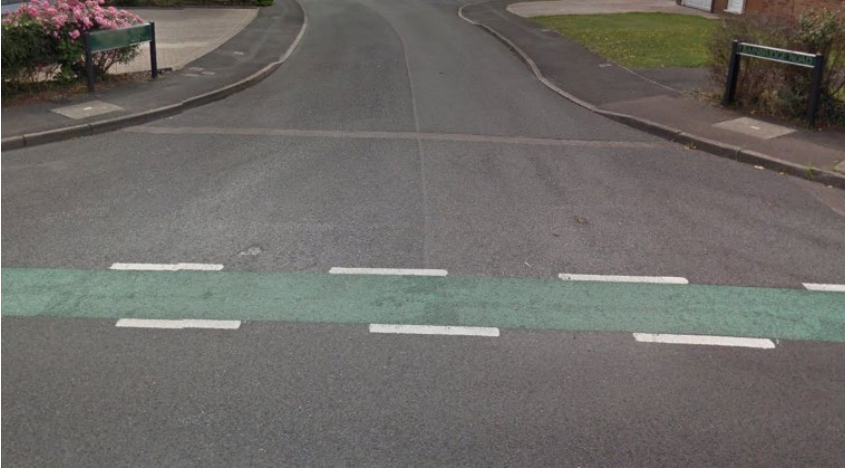
Bainbridge Road, Dorking Way: dropped kerbs to enable accessible route

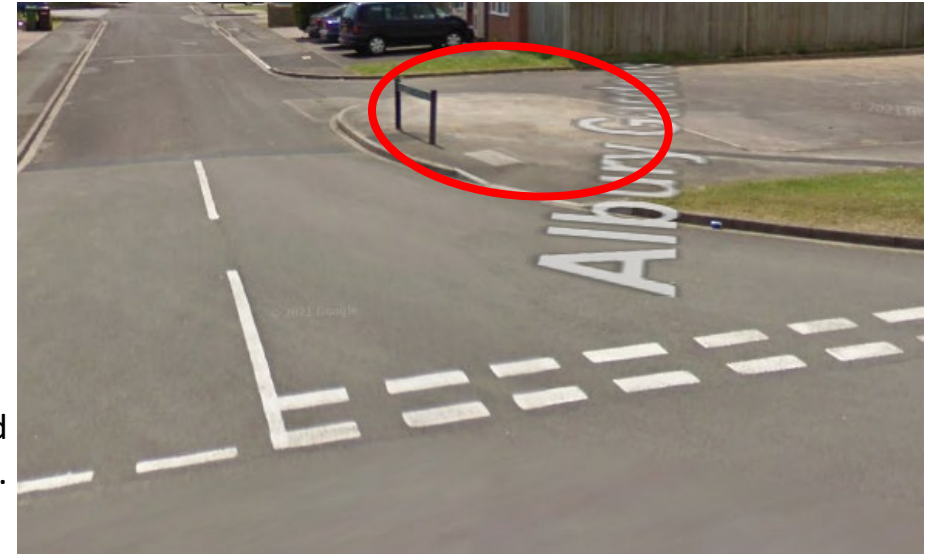
Albury Gardens: residents park on marked area. Consider making an official space.

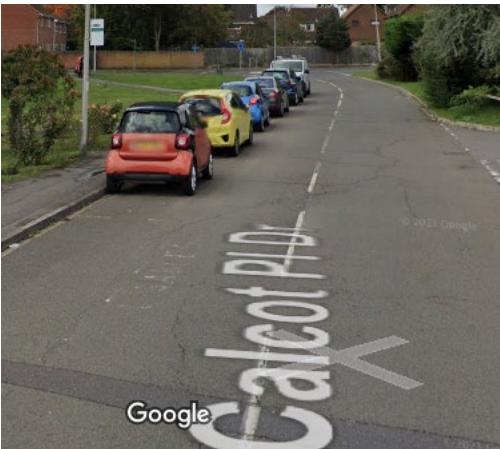
On road parking issues – consider encouraging residents to apply for permission to drop kerbs outside their property to create on-property driveways – perfect example top of Calcot Place Drive.

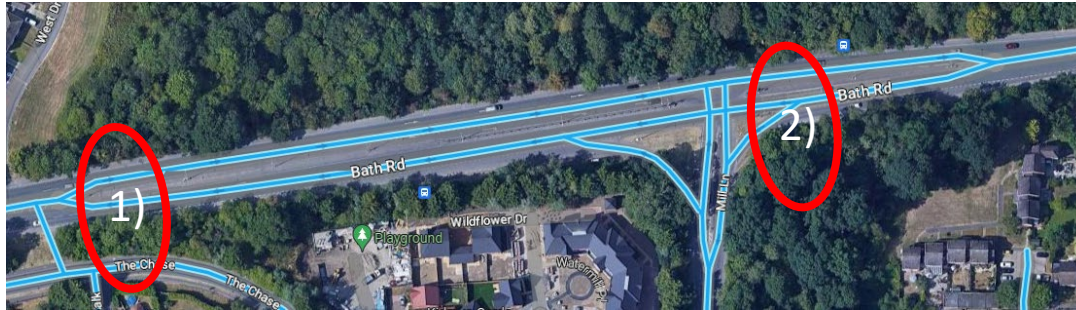
Possible pedestrian crossing points on the A4 Bath Road: 1) is indicated cycle lane from the Bath Road into Beansheaf. 2) At the A4 Bath Road/Mill Lane Junction. There are often people trying to cross this road and often run across in front of traffic. Michelle advised that this is not her department and should be discussed with Neil Stacey's team.

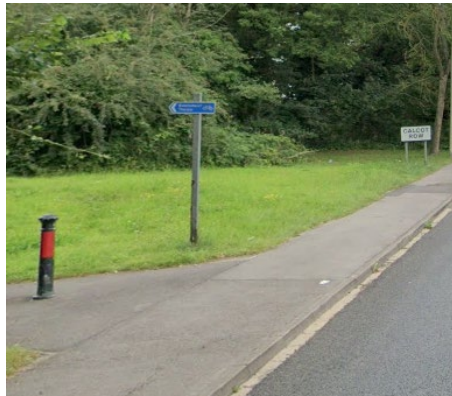
Consider the relocation or removal of this sign? (A4 Bath Road to The Chase).

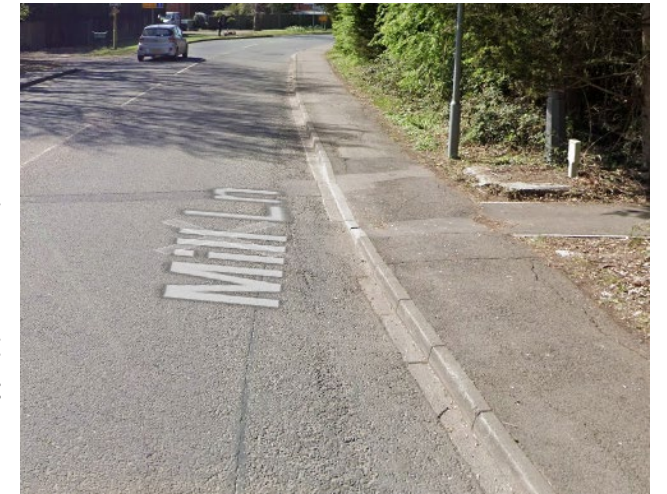
Concern with the location of the crossing out of the Red Kite Close estate onto Mill Lane. Consider a raised zebra crossing opposite Low Lane (better visibility, will slow speed) and raising the current dropped kerb to encourage a better crossing point (existing opposite an cul-de-sac entrance; conflict of priority traffic)
